INIT status - What is necessary to check, if INIT led light on VoIP card shines red?

This guide is for VoIP card, which is identified in Diagnostics window as VIP172.

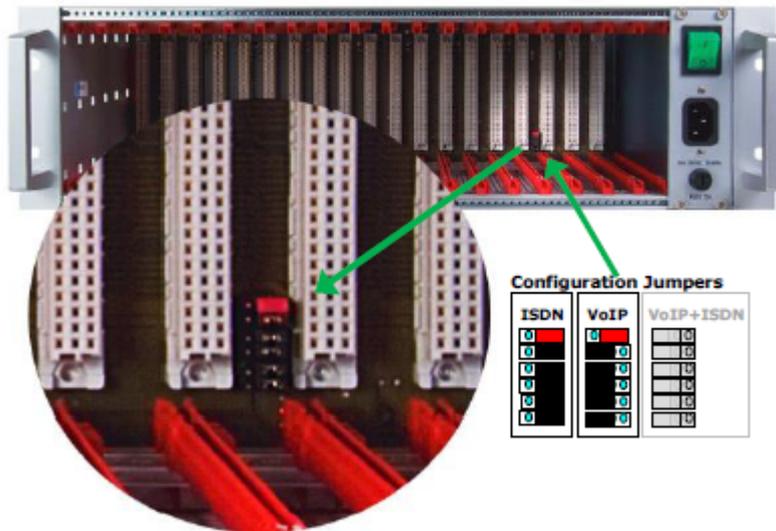
1. Jumper field:

If the gateway is new or if you are rebuilding the gateway from ISDN to VoIP, please check following:
