Firmware upgrade - How to make a firmware upgrade on 2N® Lift8

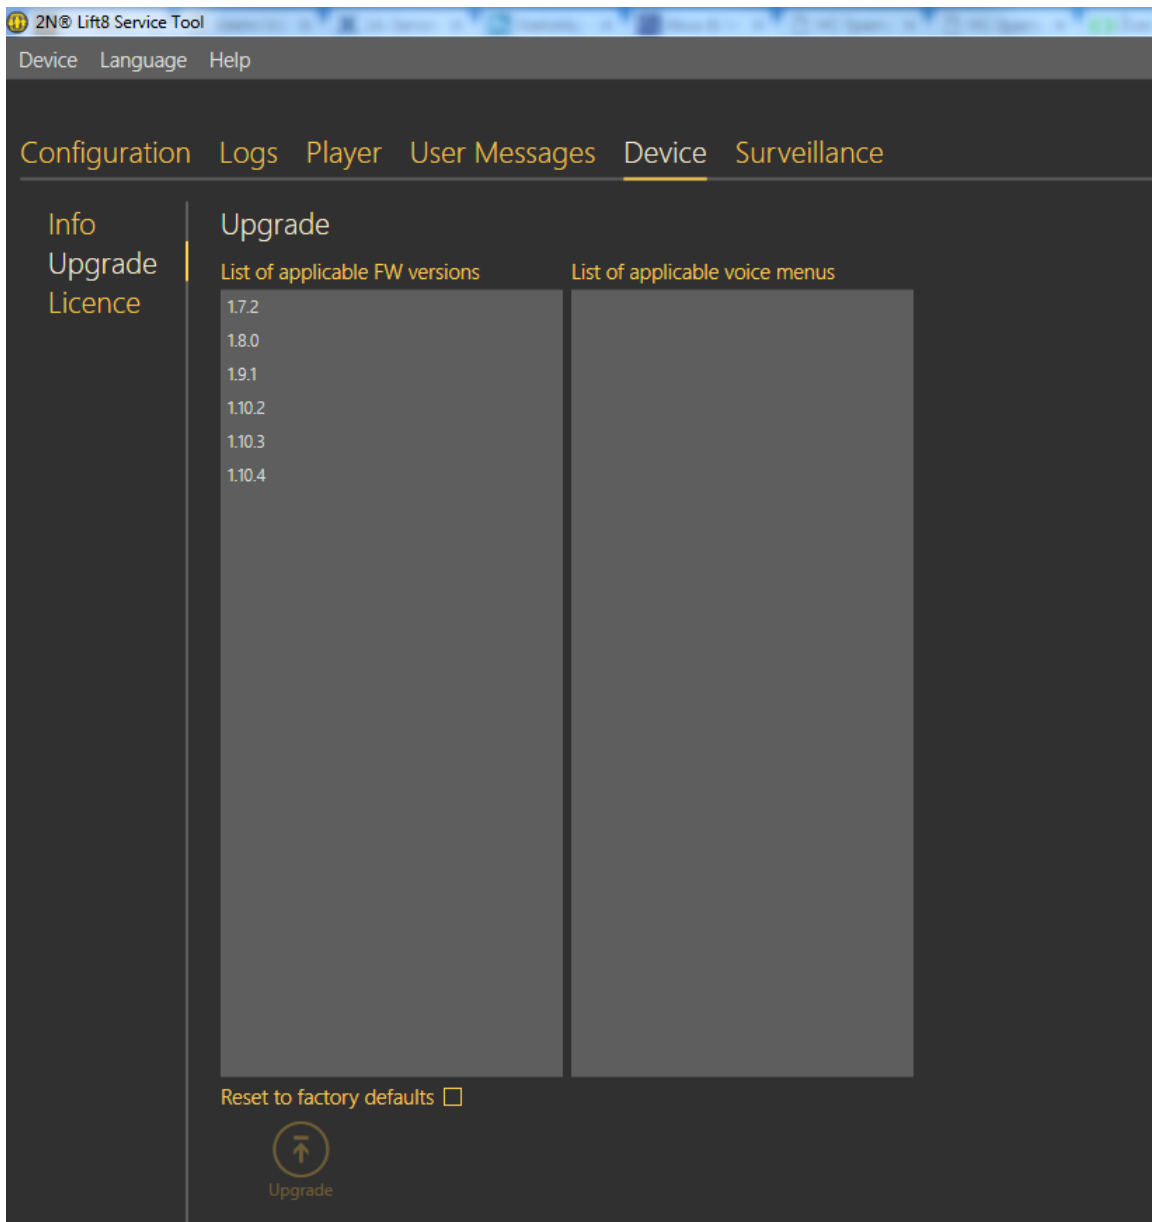
In the Service Tool in the Menu Device-Upgrade where you can see the list of all applicable fw versions and language packages (voice menu):

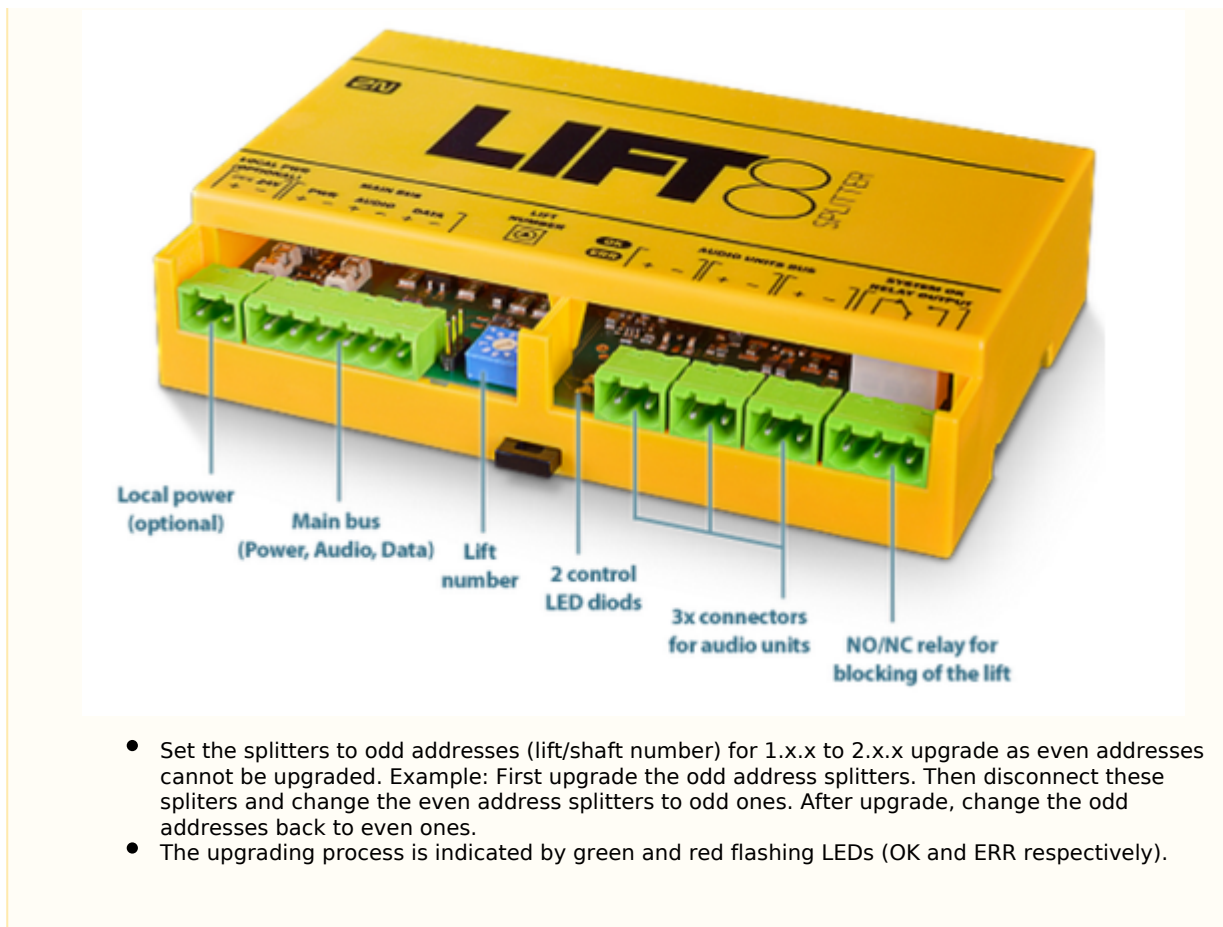
Splitlers needs special treatment for firmware upgrade between 1.x.x. and 2.x.x versions:

- Set the splitters to odd addresses (lift/shaft number) for 1.x.x to 2.x.x upgrade as even addresses cannot be upgraded. Example: First upgrade the odd address splitters. Then disconnect these splitters and change the even address splitters to odd ones. After upgrade, change the odd addresses back to even ones.
- The upgrading process is indicated by green and red flashing LEDs (OK and ERR respectively).
